CONCRETE CANVAS®

Concrete on a Roll

SLOPE PROTECTION CASE STUDIES

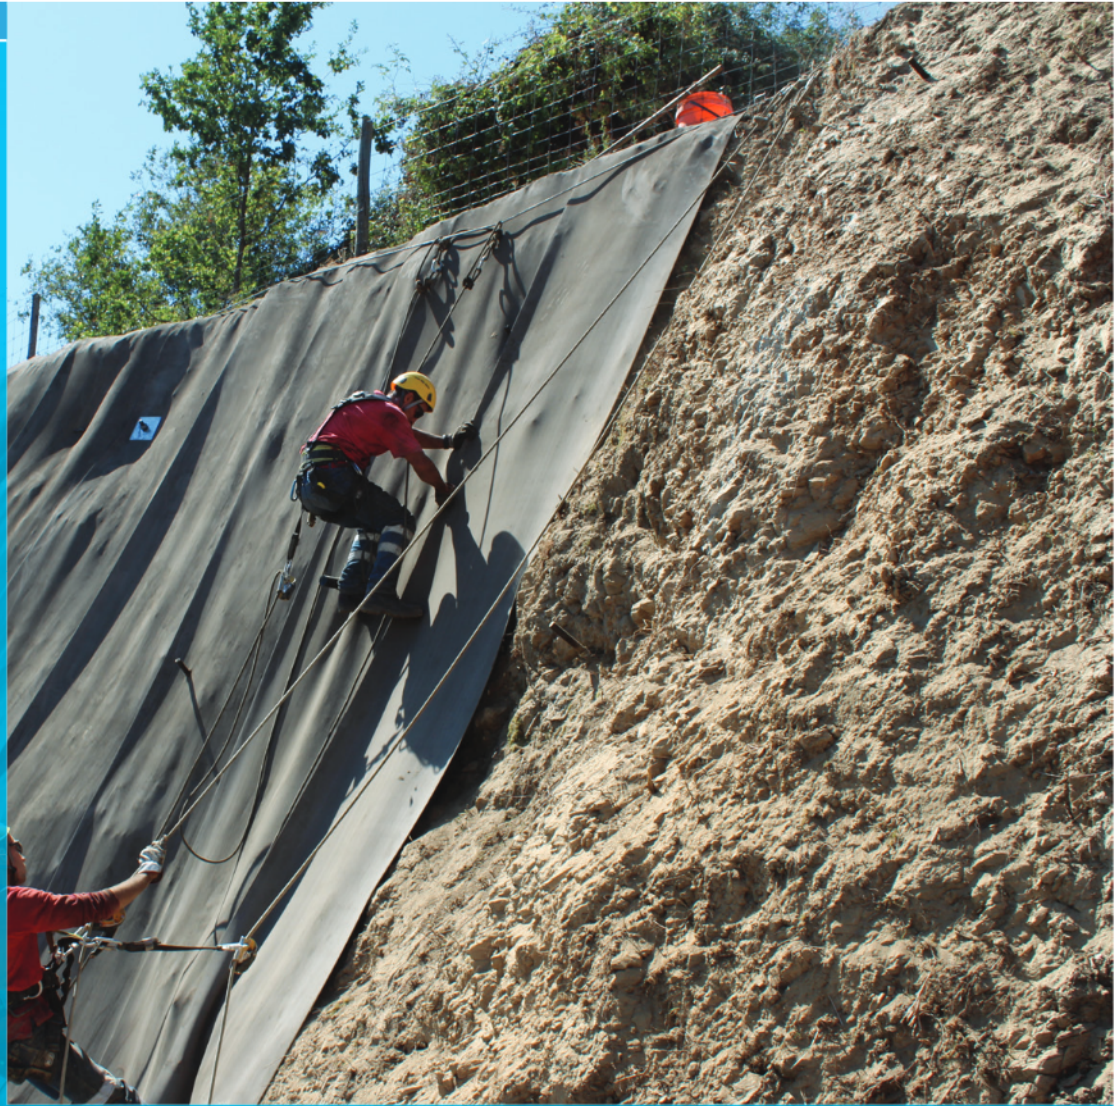
The installation team at Highway A24 had to use climbing equipment due to the restricted access of the site

To prepare the slope, vegetation and large rocks were removed. Bulk rolls of CC5™ were delivered to site, mounted onto a spreader beam and hung from a truck crane at the base of the slope. The roll was then positioned at the top of the slope, the edge of the material fixed at the crest with ground pegs and the material unrolled downwards, with subsequent layers overlapping by 100mm. The CC was fixed to existing concrete infrastructure using masonry screws, and along overlaps with stainless steel screws at 200mm intervals, with alternating screws positioned closer to the edge, forming a triangular shape. Once installation was completed, the CC was hydrated, with re-hydration given an hour later due to high temperatures of 40°C.

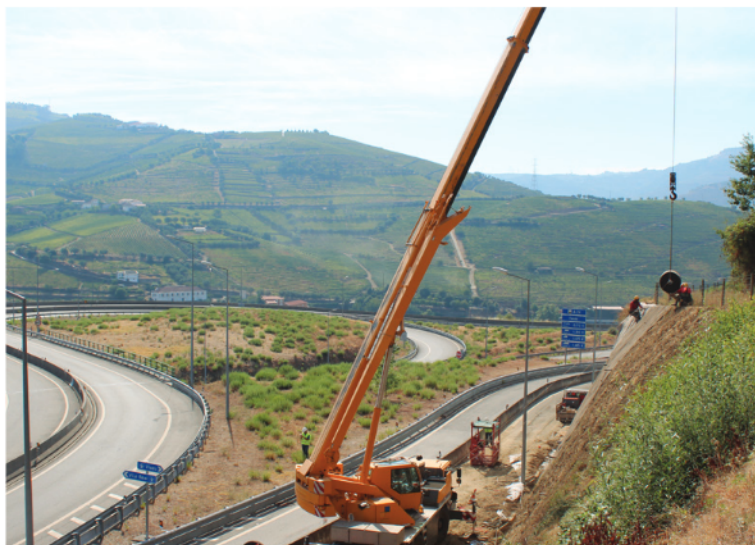
The CC was mounted onto a spreader beam and hung from a truck crane

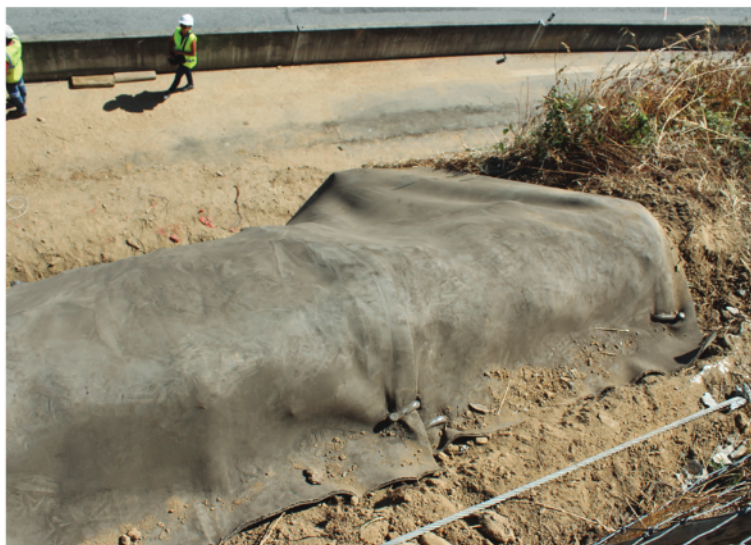
380mm ground pegs were inserted every 1m

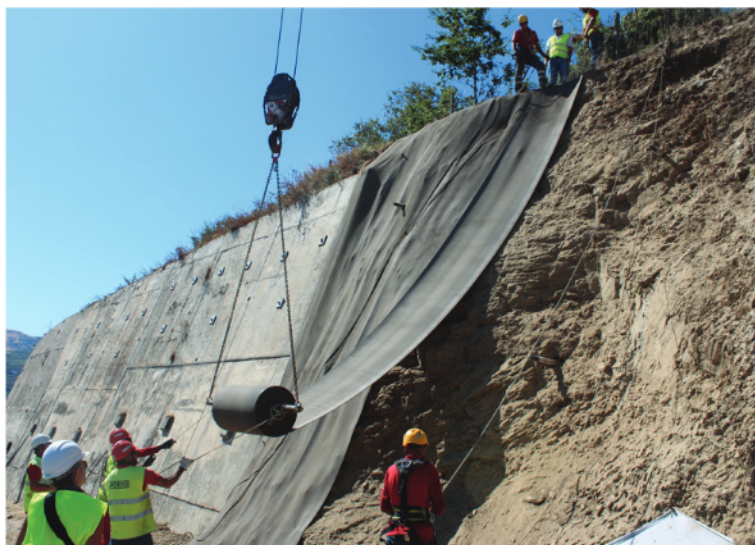
Vegetation and any large rocks were removed, prior to installation

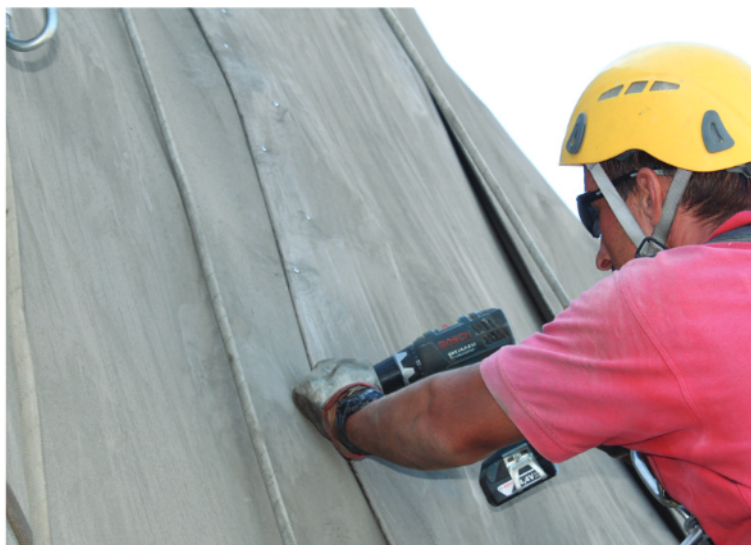
Every other screw was closer to the edge, forming a triangular shape

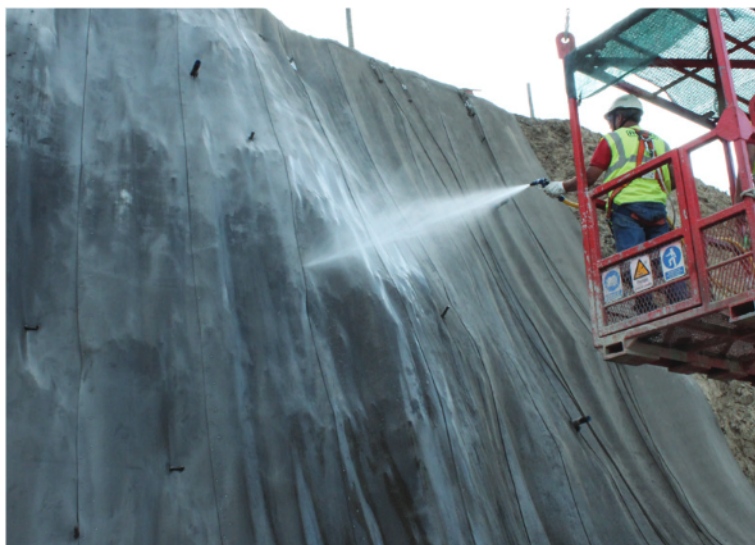
Hydration was achieved using two 1000ltr water tanks with spray nozzle

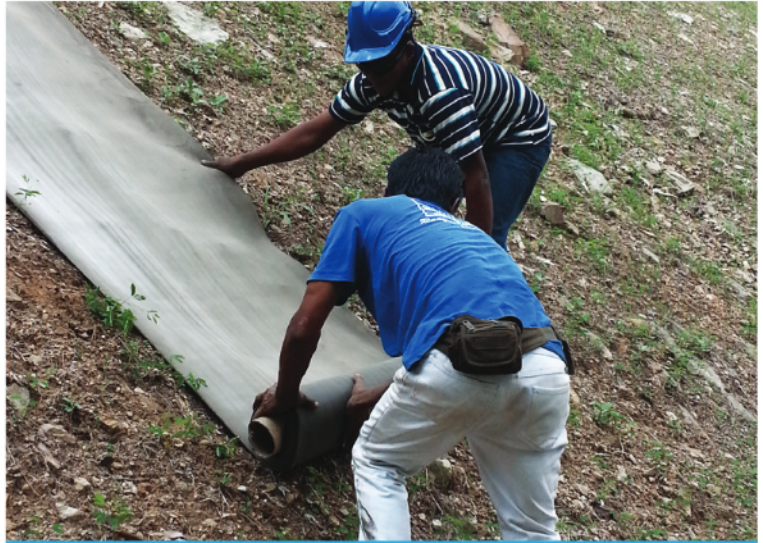
Unrolling the CC

Vegetation and loose rocks were removed from the slope before batched rolls of CC5™ were delivered to site. The CC was pegged at the crest through the overlap before being unrolled down the slope by hand, with the installation team ensuring there was a 100mm overlap between subsequent layers. Pegs were also used where necessary down the face of the slope, to ensure intimate contact with the substrate. The overlaps were jointed with screws before hydration.

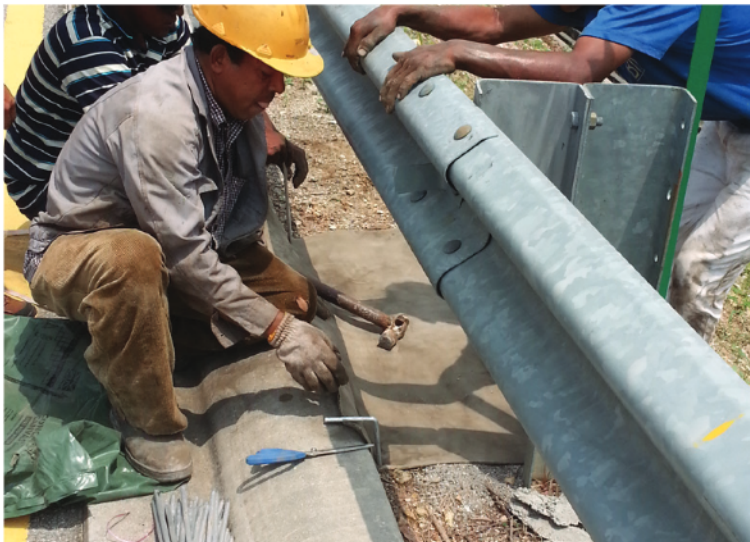
Fixing at the crest with ground pegs

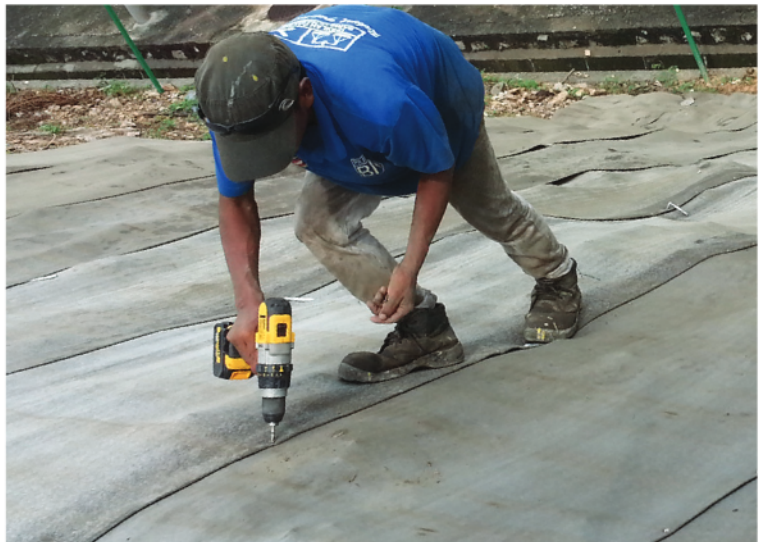
Screwing overlaps

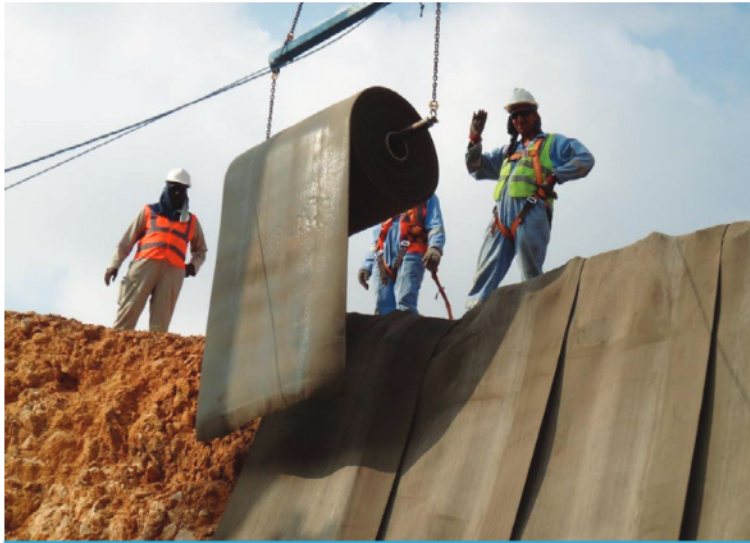
CC being lifted into position

Loose rock was removed from the slope face and bulk rolls of CC8™ were delivered to site, mounted onto a spreader beam and hung from a crane. The rolls were lifted to the crest and the leading edge pegged in an anchor trench. The rest of the CC was then unrolled down slope and cut to length. This process was repeated with layers overlapping by 100mm. The overlaps were sealed with CT1 sealant and screwed at 100mm centres in 2 offset rows. Pegs were also inserted where needed as extra precautions against high flow rates. At the base, mortar was used to seal the CC to existing concrete infrastructure, and pipes were installed to allow egress of water, preventing the build up of hydrostatic pressure behind the CC. Once installation was completed, the CC was hydrated; this was repeated an hour later.

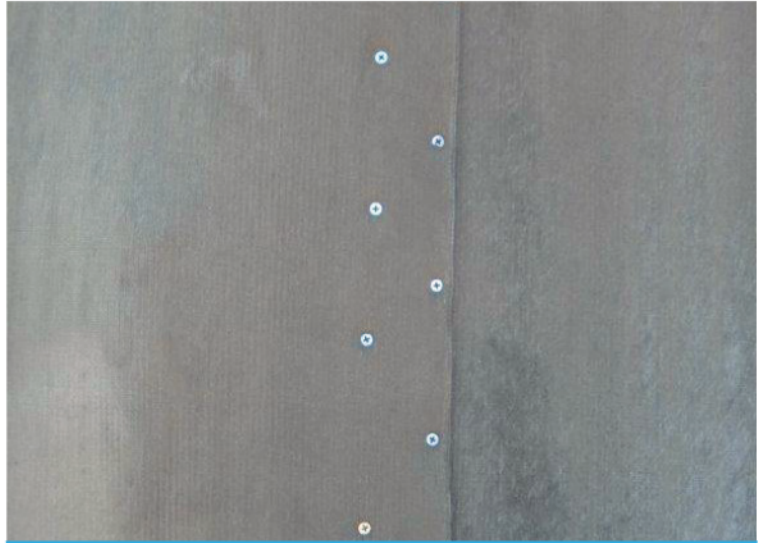
CC jointed with two offset rows of screws

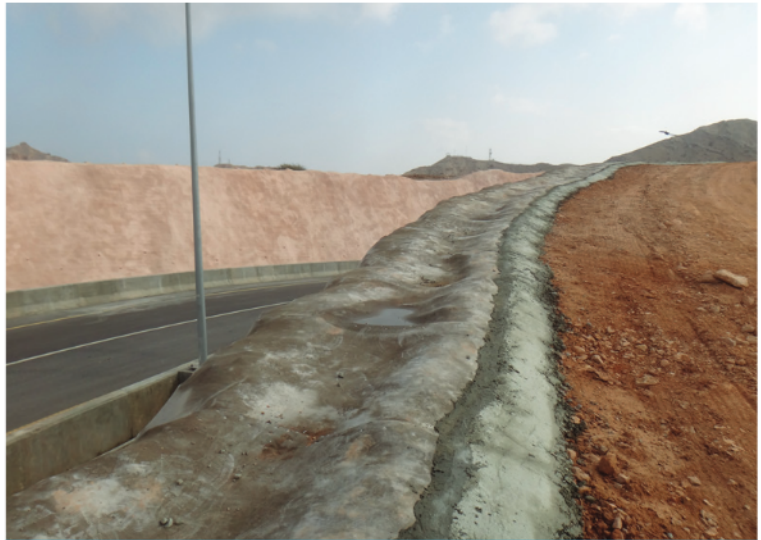
Anchor trench at the crest of the slope

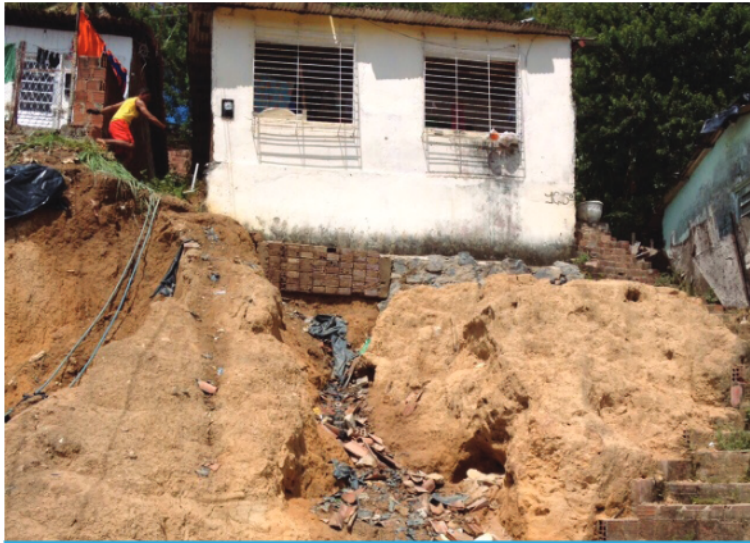
Extensive erosion of the slope

The slope was facing severe erosion problems which had led to the collapse of a house at the crest of the slope. Shotcrete was considered, but due to the varying profile of the slope and the site location this would have been logistically complex and was therefore ruled out. A gel and geotextile combination was also an option, however, it was decided this solution was too fragile to cope with the anticipated weathering erosion. Additionally, previous installations of this material had been subject to theft. Due to CC's resistance to impact, UV degradation and its estimated 50 year life-span, it was installed as a trial to assess its suitability for 1,400 similar projects within the municipality.

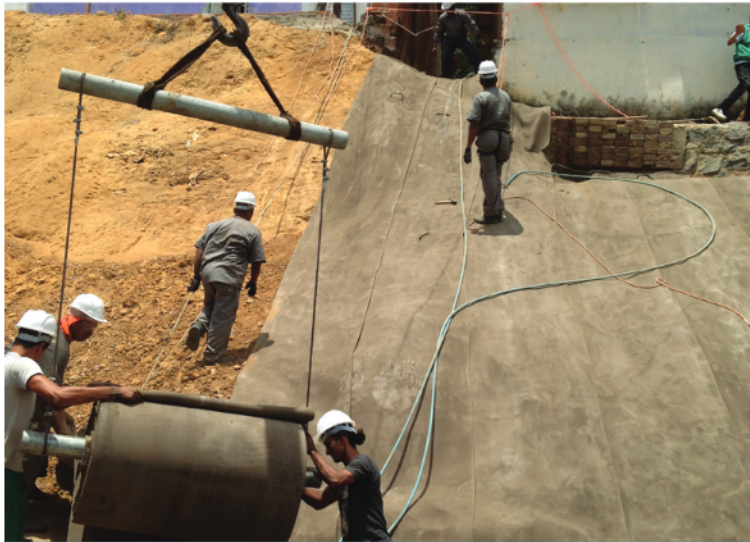
CC spooled down the slope

The slope ranges in height from 5m to 12m and is surrounded by housing. Loose soil, rock and vegetation was removed and the surface re-graded to ensure intimate contact between the CC and the substrate. The nearby stairs and a masonry wall were repaired with concrete as part of the works. A bulk roll of CC8™ was delivered to site and mounted onto a spreader beam hung from a crane. For the smaller lengths, the CC was unrolled on the flat, cut to specific length and positioned onto the slope by hand, with the installation crew ensuring there was a 100mm overlap between layers. For the steeper, taller parts of the slope the CC roll was positioned at the top of the slope and spooled down, reducing the manual handling requirement.

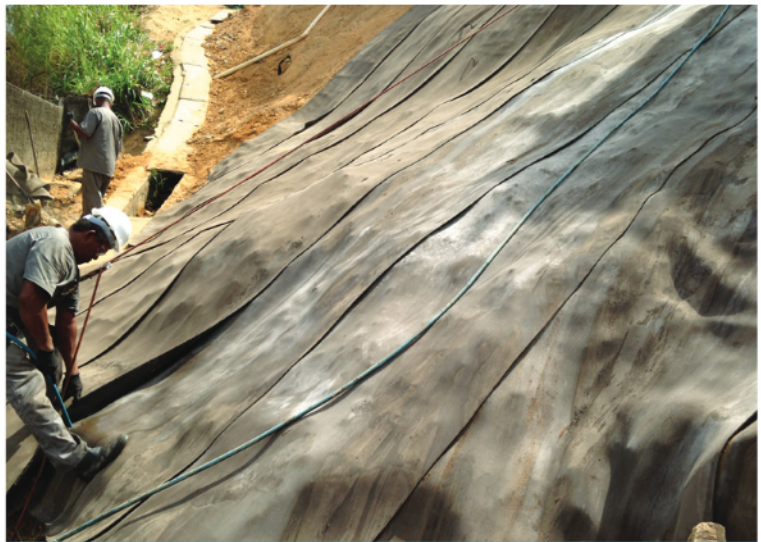
Hydrating under the overlap

The CC was initially fixed at the top of the slope to allow the installation crew to hydrate under the overlap before fixing and jointing. 400mm ground pegs were then inserted through the overlaps at 2m intervals to fix the CC to the slope. To joint the overlaps a double row of screws were applied at 200mm centres using an auto feed screwdriver, then hydration was completed using an 8000L bowser and hose with spray nozzle attached. A concrete mortar was used where CC terminated onto masonry infrastructure and, once set, the slope was painted to match the surroundings.

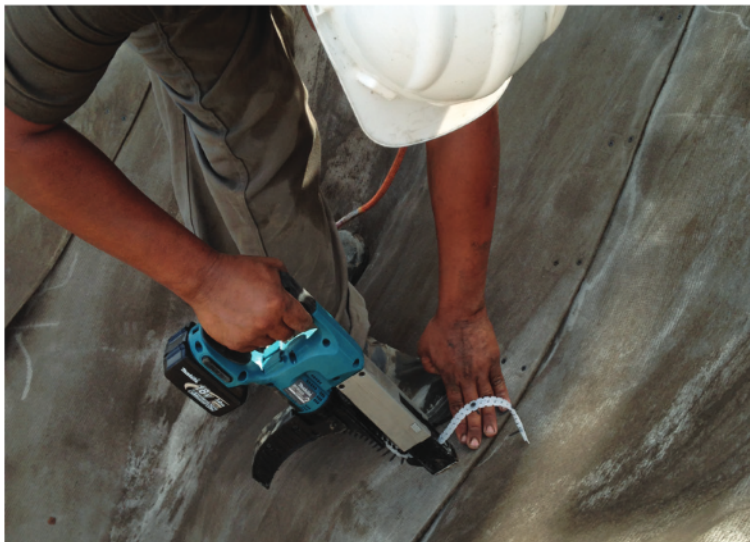
Joints were screwed every 200mm with a double row of screws

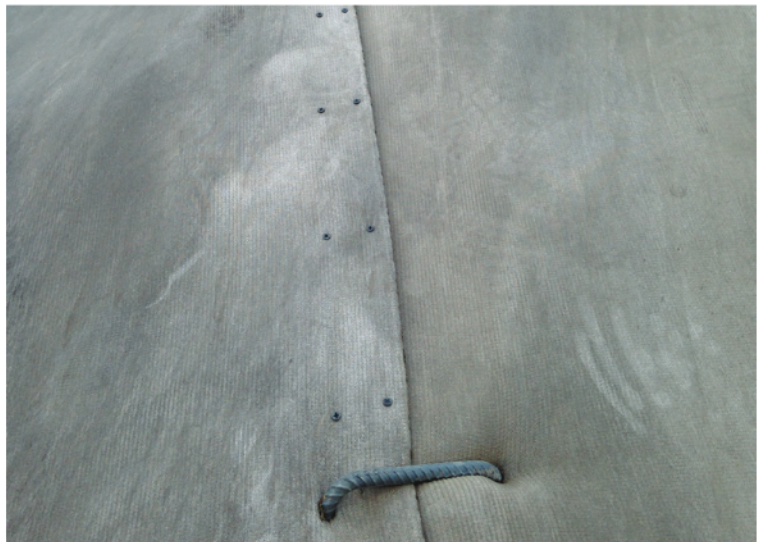
Pegs were inserted through every overlap at 2m intervals

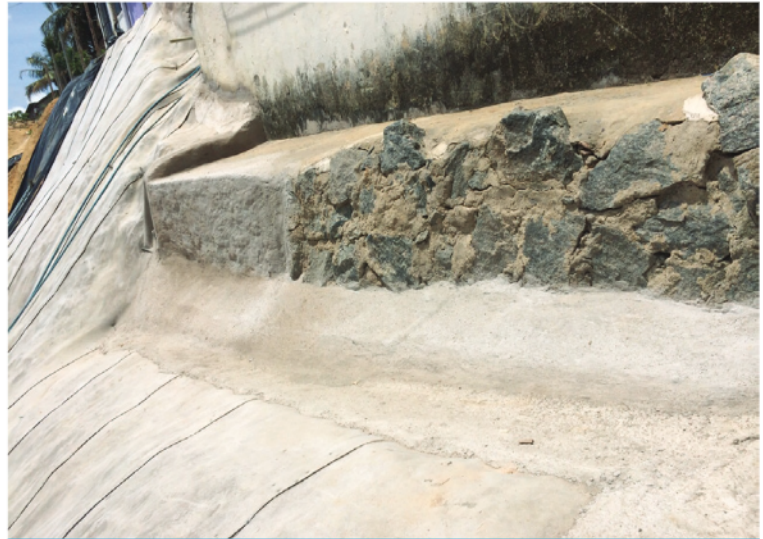
Mortar joint

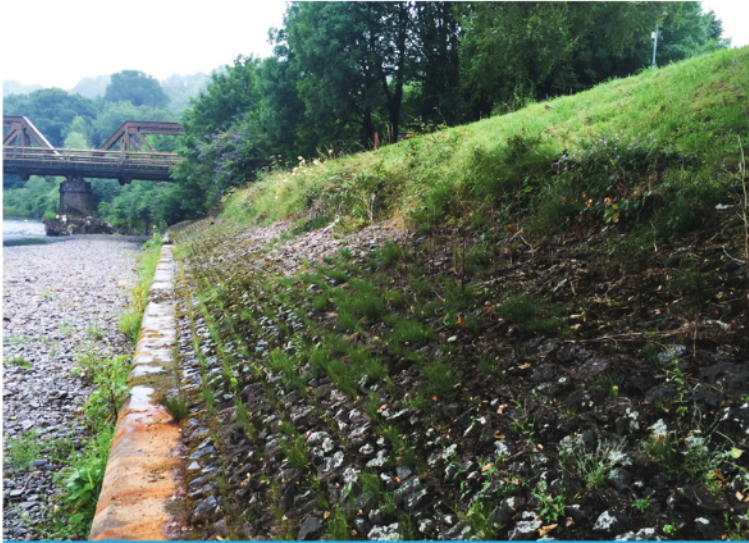
The rip-rap embankment prior to installation

In November 2016, Concrete Canvas® (CC) GCCM* was used to line sections of embankments of the River Taff in Pontypridd, South Wales. A particular section of the river, within the Treforest Industrial Estate, was showing signs of degradation; the existing concrete riprap was heavily cracked, spalled and showing established vegetation growth. Lining of the slope was required to provide an effective erosion protective layer to prevent further scour.

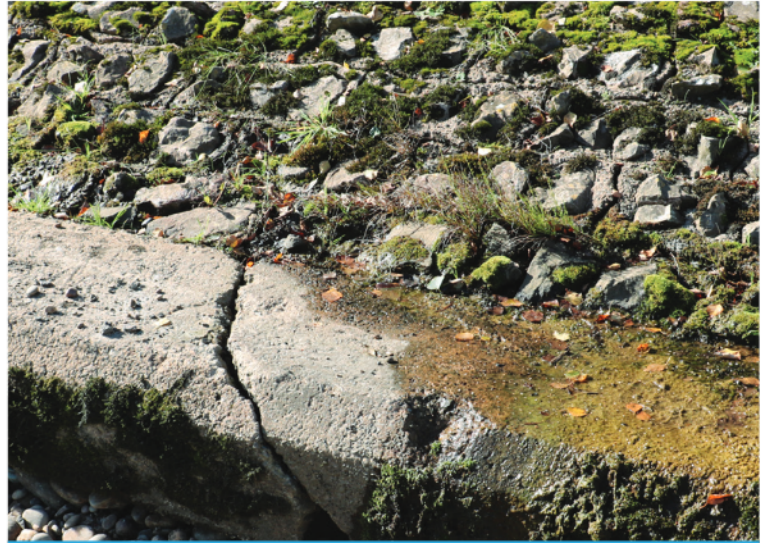
An area of the concrete curb which had badly cracked

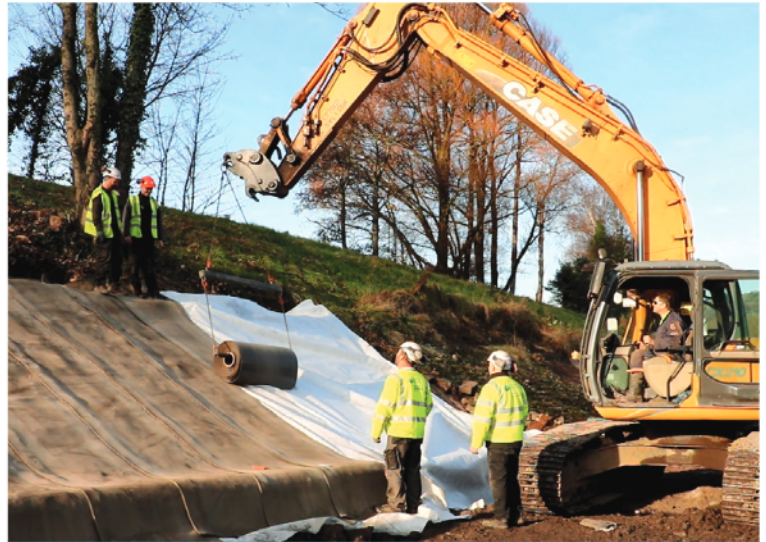
Deployment of CC over the geotextile

The CC was then laid over the geotextile, with layers overlapped by 100mm, and screwed together through the overlap at 150mm intervals. The lack of sealant and the use of the geotextile would allow the release of any build-up of hydrostatic pressure, as well as creating a natural water transition between the substrate and CC.

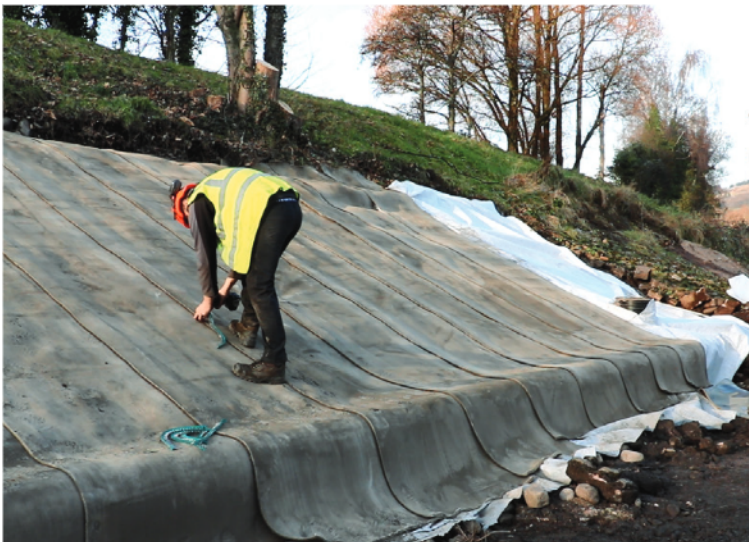
Fixing of the CC layers using screws

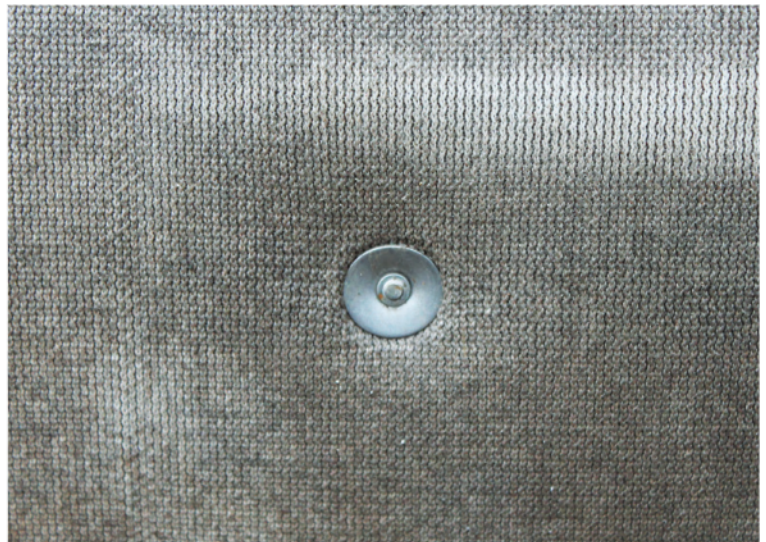
Hilti shot fired masonry nail with washer to secure the CC to the curb

At the crest, the edges of the CC were captured and pinned using steel pegs within an anchor trench, which was then backfilled. The concrete kerb at the toe of the slope allowed the CC to be fixed using masonry anchors. The side edges of the CC were also anchor trenched within concrete poured backfill to prevent ingress. A series of drainage chambers were installed along the length of the embankment. The CC was hydrated directly from the river.

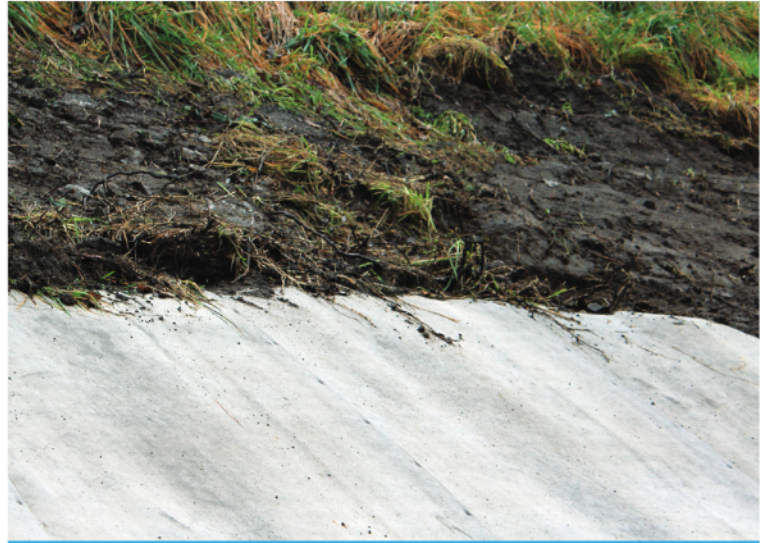
Anchor trenching of CC13 midway up the embankment.

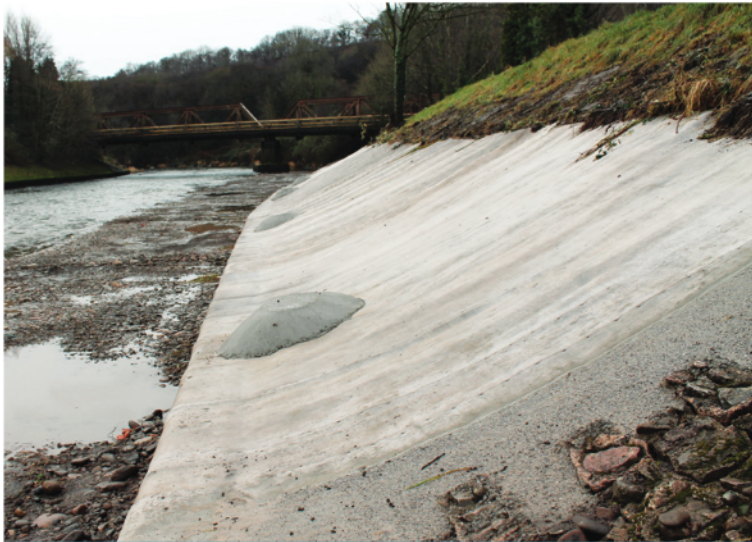
Grouted termination to rip-rap

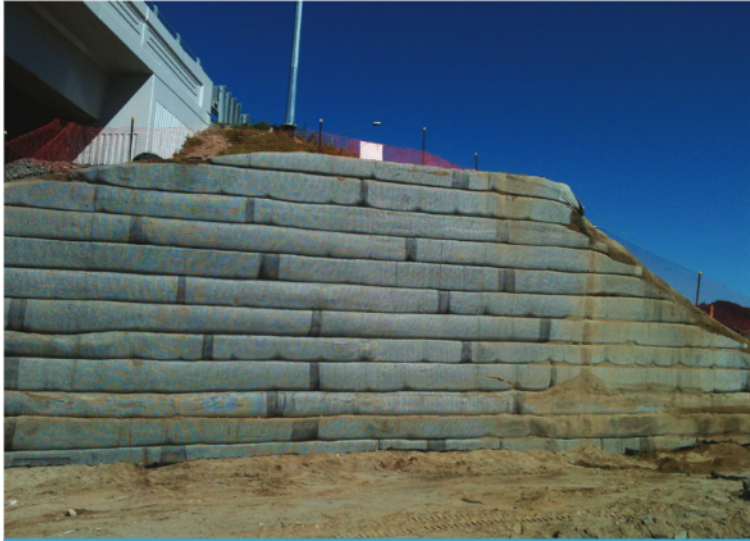
The abutment had been prepared with a geogrid prior to installation of CC

In September 2013, Concrete Canvas® GCCM* (CC) was used as an erosion control solution on a section of bridge abutment in Taupiri, New Zealand. The CC was being installed as a capping layer to an existing geogrid system. Shotcrete was initially considered for the project, but would require specialist equipment and labour, as well as extending the installation time. The works were carried out by Fletcher Construction, Brian Perry Civil and PC Environmental.

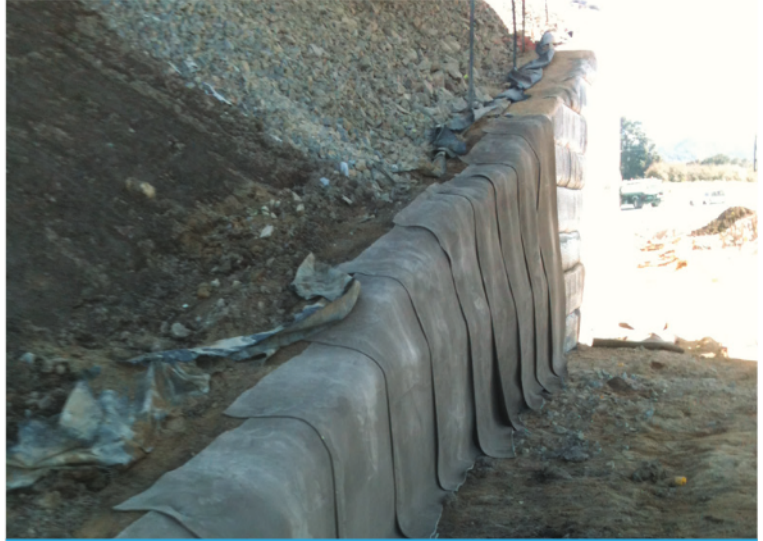
CC5 was cut to length on site to match the varying height of the abutment

Bulk rolls of CC5™ were delivered to site and cut to lengths of between 1m and 7m to match the varying height of the slope. This ensured that there was no wastage as each length was tailored to match the slope face exactly. Using a rough terrain cherry picker and spreader beam, each length was then lifted to the top of the slope and fixed in place using 300mm steel ground pegs at the crest and toe. This became more difficult on the sections of abutment directly under the bridge, an issue that was solved by reversing the process and fixing the CC to the toe of the slope first. Subsequent layers of CC were then positioned with an overlap of 100mm to the adjacent layer and screwed together with 30mm screws at 200mm intervals using an auto-fed screwdriver. Once the CC had been secured, it was then hydrated using on-site equipment and a water truck.

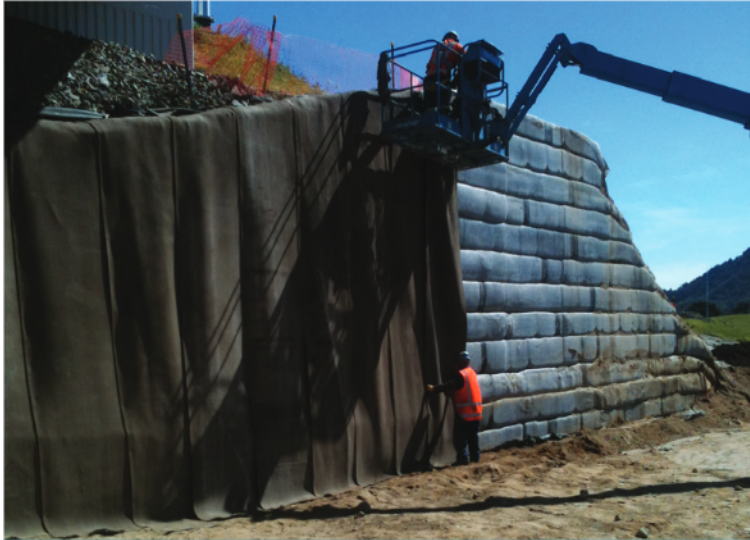
A cherry-picker was used to lift sections of CC to the top of the slope

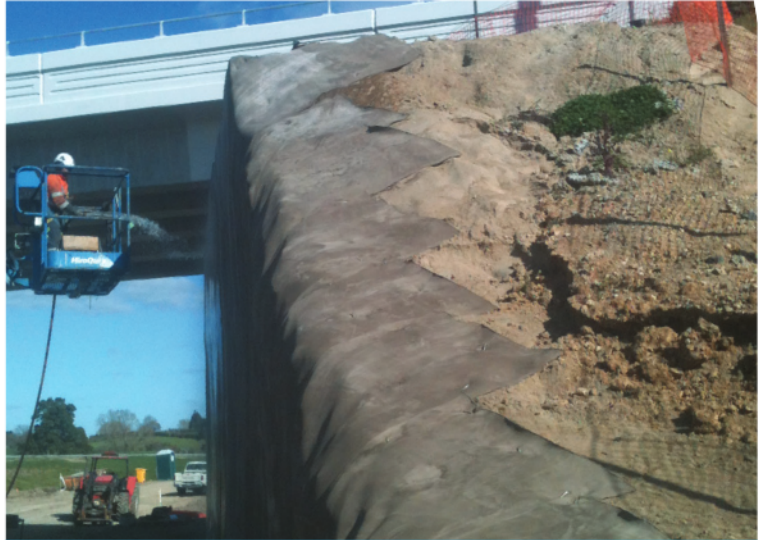
CC fixed in place with ground pegs and hydrated
